# Report Index

# INSPECTION CONDITIONS

**5220 Mockingbird Lane  
Atlanta, GA 30328**

Inspection conducted by Paul  
Davidson  
GAHI#345-98

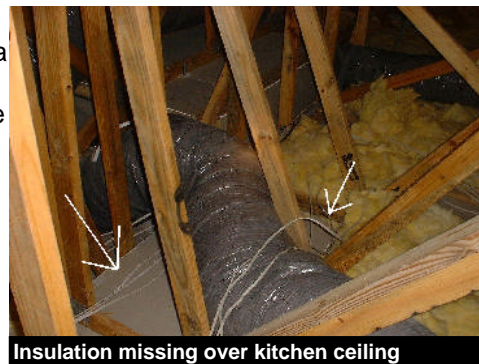
Fiberglass batts, Some insulation is installed unevenly over the kitchen area with poor general coverage. Recommend additional insulation in the attic area to improve energy efficiency.

Insulation missing over kitchen ceiling

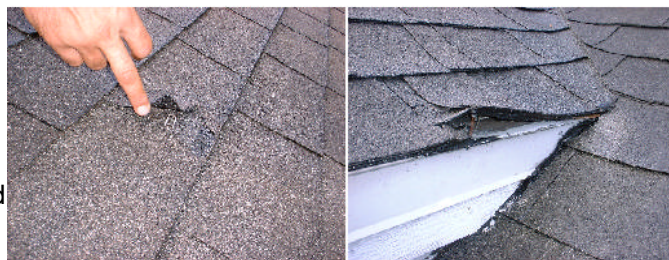
General condition appears serviceable with signs of weathering/curling and aging. [This roof is now 12 years old.](#) Regular maintenance and inspections are advised so you can make reinforcements as needed to prolong roof life. **Some repairs are needed now.** Nails/Fasteners are protruding from the roof surface at the rear of the roof, and flashing is uplifted and in need of repair at the front right gable. Each of these areas represents a potential area of leakage, if not now, then in the near future. [A licensed roofing contractor should be called to make further evaluation and repairs as needed.](#)

Protruding staple - Uplifted edge flashing

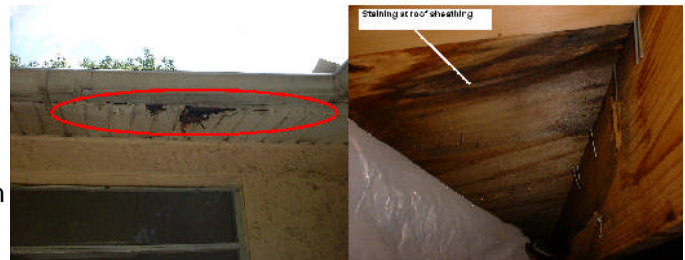
Aluminum. Damage is noted- along the overhang at the left side of the house.

**Active leakage is noted within the attic area** under this portion of the roof, as shown in the 2nd photo. [A licensed roofing contractor should be called to make further evaluation and repairs as needed.](#)

**Damaged Overhang/Roof Problems/Leakage**

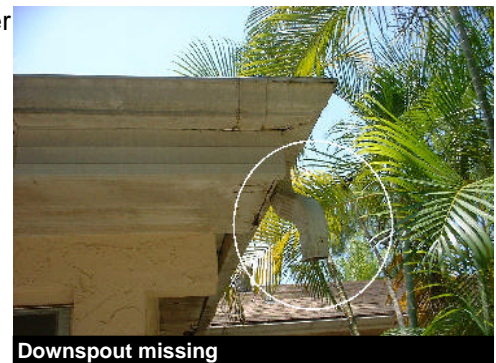
Partial, Damage/Defects viewed Gutter downspout is missing from the left rear corner of the flat porch roof. Some erosion is taking place. Replace as needed.

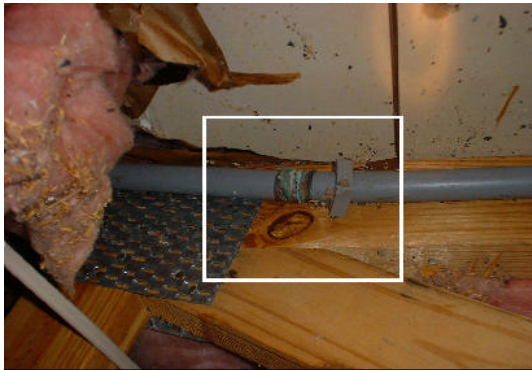
Appears serviceable, however, active leakage is noted at a crimped joint located over the family room. It's is a small drip at this time, but could result in catastrophic failure without warning. For this reason alone, repair should take place without delay. Budget \$200+

Active leak at plastic water pipe in attic

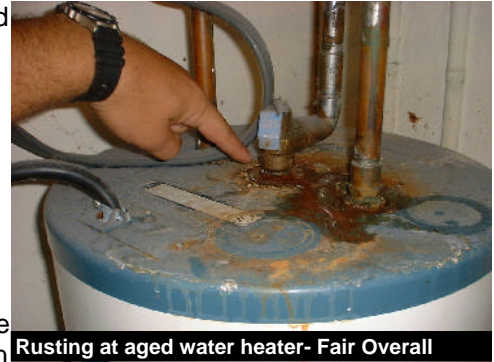
**TYPE:** Electric.  
**SIZE:** 40 Gallons.  
**LOCATION:** Garage.  
**CONDITION:** Leakage has occurred at the connected piping above the unit, causing rust to form at the top of the unit. Pressure relief valve noted, not tested, A water shutoff valve is installed but does not appear like it would work, due to rusting. No ongoing leakage is noted, but this unit now exceeds 10 years of age and will likely need replacement in the not too distant future at a cost of \$300 or so. Electric water heaters have expected service lives of 10-15 years in this area of the country.

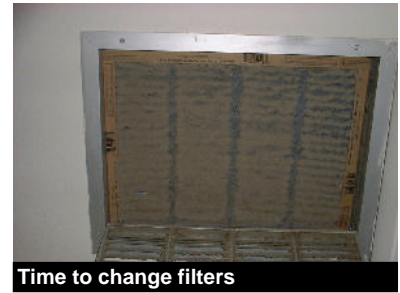
**AIR FILTERS:** Suggest cleaning/changing filter.

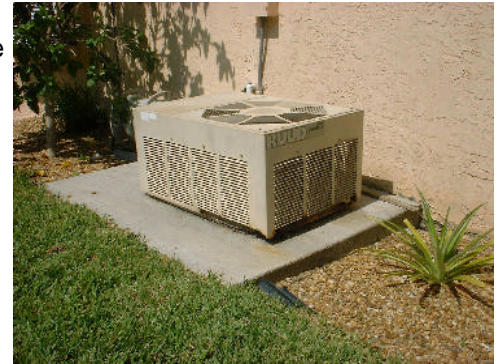
**TYPE:** Central, Electric- The air conditioning system is completely separate from the heating system. System is operational, however, we recommend clearing foliage from unit.

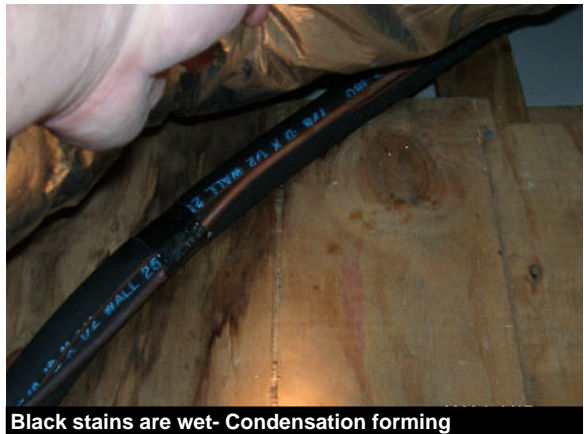
Condensate line runs from the evaporator in the attic over the family room to the right exterior wall. CONDENSATE DRAIN LINE IS SWEATING: The condensate drain line from the air conditioning evaporator cabinet (air handler) has a tendency to sweat during hot weather, when the system is operating most of the time. Inexpensive pipe insulation should be added to the first 5 feet of this line to alleviate this condition, which if left

unattended, can cause damage to ceilings. Uninsulated portions of refrigerant suction lines also can result in condensation formation and subsequent dripping and damage to attic ceilings. The remedy is the same, with addition of foam pipe insulation to remedy the problem. At this point, you may want to call a contractor who can offer a warranty on their work to make repairs.

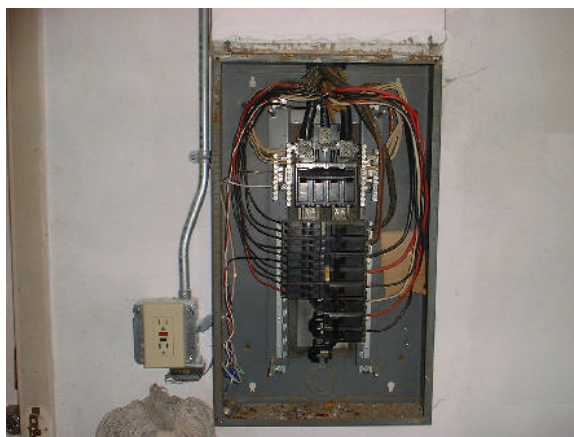
Circuit and wire sizing correct so far as visible, Grounding system is present, but loose clamp at water line or ground rod. Tighten as needed. Unused openings in the panel are missing covers, Panels are without the benefit of complete labeling.

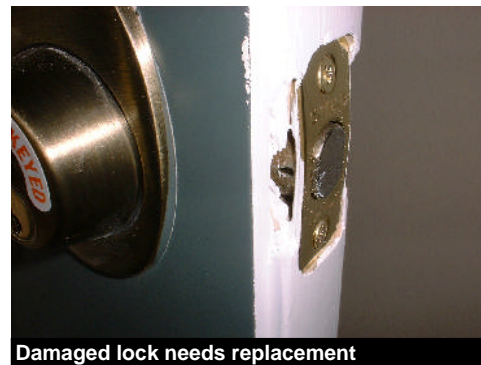
Appears serviceable, Dead Bolt is not operational, due to damage. Replace as needed.

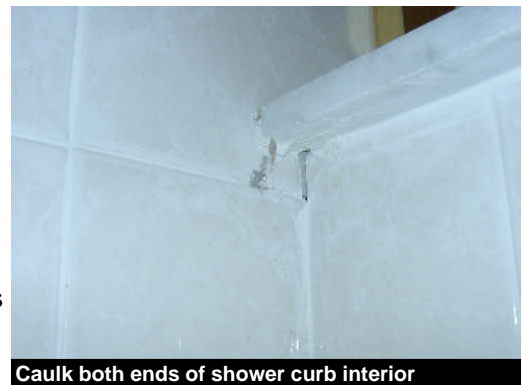
Tub and shower areas appear serviceable. Cosmetic moisture damage is noted at the wall or floor outside the tub/shower area. Caulking and/or re-grouting is needed to prevent water intrusion. Enclosure appears serviceable, but open gaps are seen under the interior of the shower curb. Caulk and seal all tub and shower areas as a precaution.

Caulk both ends of shower curb interior
