# Report Index

# INSPECTION CONDITIONS

**5220 Mockingbird Lane  
Atlanta, GA 30328**

Inspection conducted by Paul  
Davidson  
GAHI#345-98

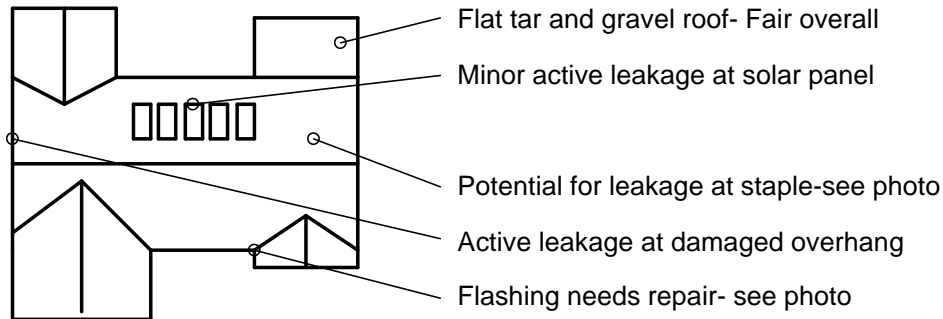
## PLAN VIEW OF ROOF (not to scale)

Aluminum. Damage is noted- along the overhang at the left side of the house.

**Active leakage is noted within the attic area** under this portion of the roof, as shown in the 2nd photo. [A licensed roofing contractor should be called to make further evaluation and repairs as needed.](#)
